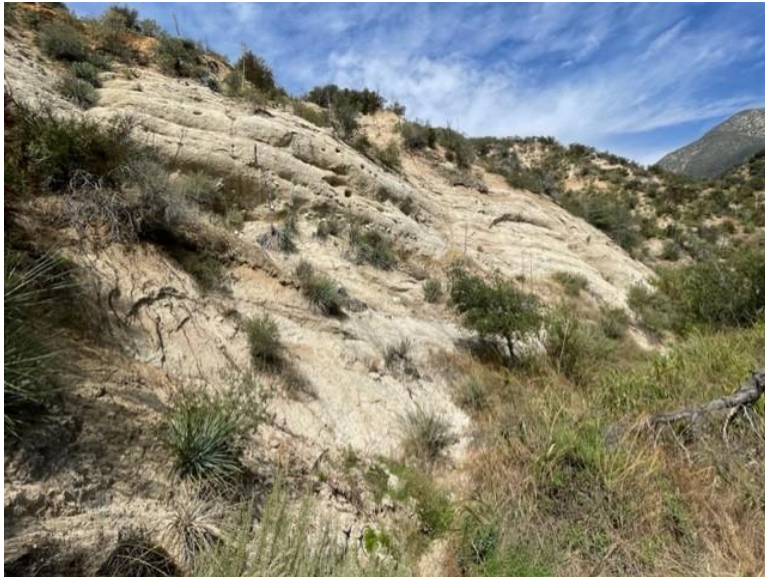
**Abiota-** With just hours remaining in our September 30-October 1 Water Year, we received enough precipitation to push our water year total to an even 1,000mm (yes, a full meter). There is still flow in Gold Creek in all areas of our property. There is also a small amount of flow from Center Creek. The cliff is the source of our culvert sediment problems and road undercutting.

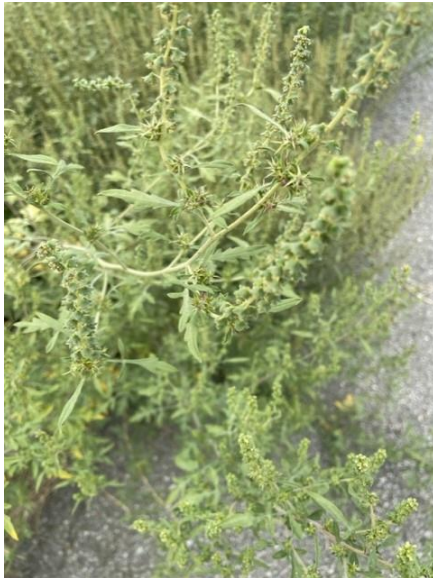
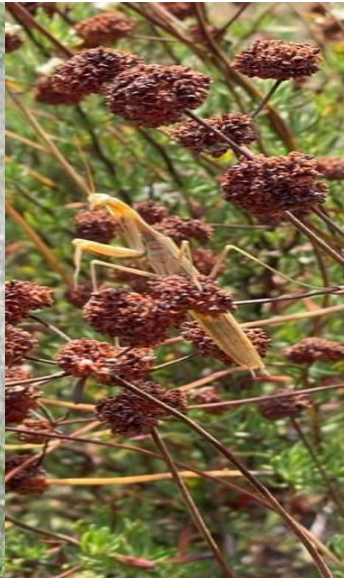
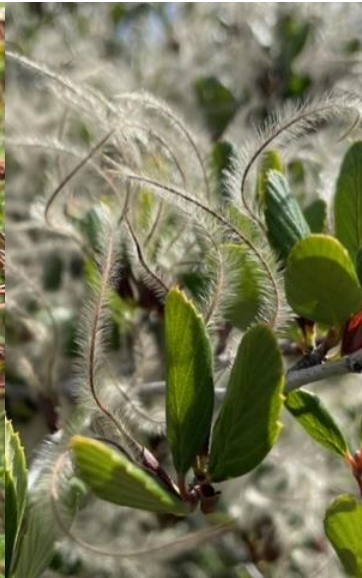
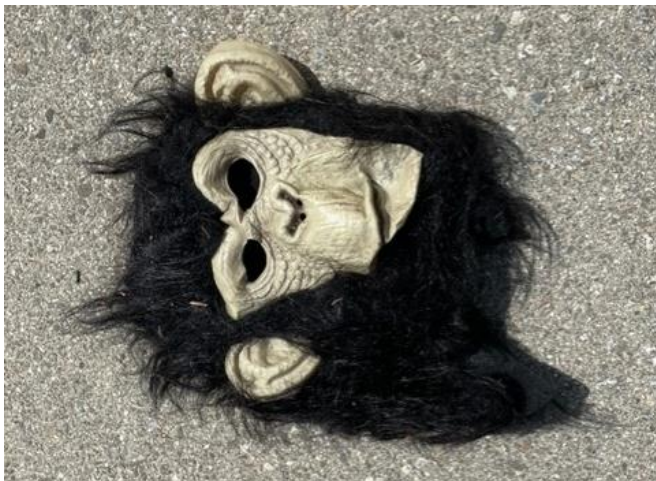
**Biota-** The vegetation is just starting to show drying out in some areas. Invasives such as Mustard and Star thistle are thick in parts of the Red Trail. Ragweed is very thick surrounding the parking area. Mallow is still flowering, and Mountain Mahogany has “feathers”.
