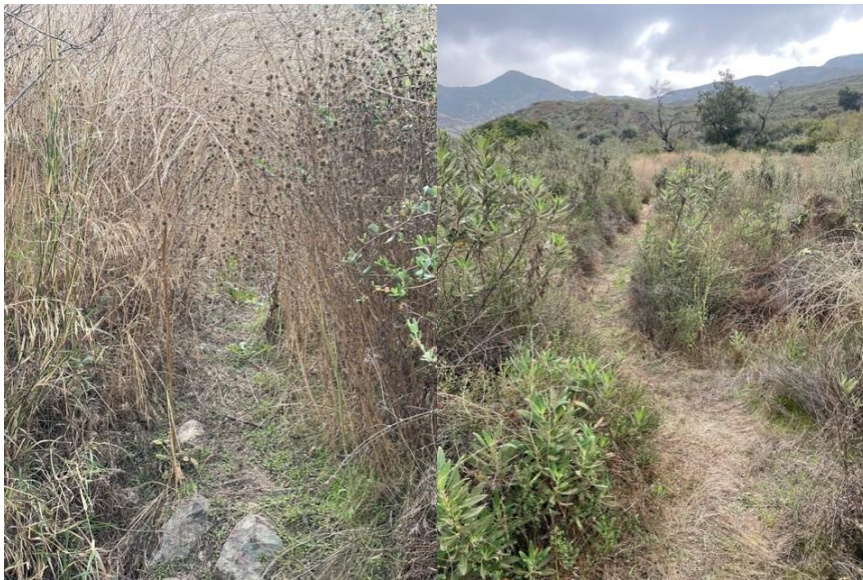
**Roads and Trails-** Road conditions have not changed since our last meeting, although vegetation is encroaching along the sides. The dirt road approaching our property remains in condition to be easily passable by 2wd automobiles and, while on our property, please use the lower portion of dirt road to avoid the undercut paved roadway. Trails have seen some work, notably the Red Trail, which is now well cleared (for a clockwise approach) up to the oak tree that sits at its highest elevation. The only trouble spots remain the initial start of the trail (the steep, wet, overgrown initial few feet) and connecting the newer cleared segments with the areas cleared in the Spring (a counter-clockwise approach). The green trail is passable with a few overgrown spots. Blue and White trails will need more work before field trips. Please reach out to me about the schedule and goals for your field trips, so that trail clearing can be prioritized where it is needed most.
